Sleeping Bear Dunes Beach/Water Access Site Accessibility Evaluation & Design Recommendations

Beach/Water Access Site: DH Day Beach

Date Assessed: 10/23/15

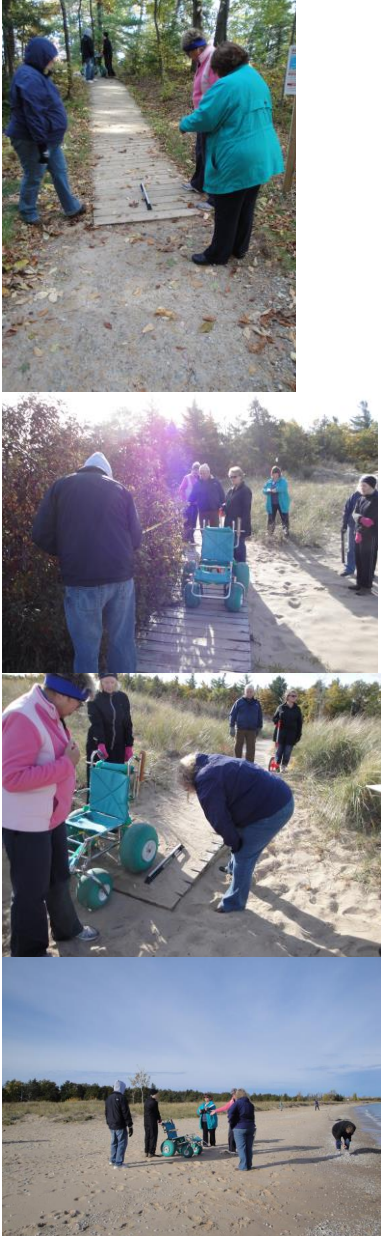
Photo/Location Description	Barrier Description	Accessibility Feature Design Recommendations
<p data-bbox="94 170 535 203">Accessible Routes to Waters' Edge</p>

<p data-bbox="598 203 1186 316">470' long boardwalk route toward the water is 48" wide with running slopes up to 14.7% and cross slopes up to 6.6%.</p> <p data-bbox="598 349 1102 422">There are no level landings at change of directions on curves.</p> <p data-bbox="598 462 1123 495">Boardwalk surface has openings up to 5.5"</p> <p data-bbox="598 649 1186 722">Encroaching vegetation narrows route width to less than 30"</p> <p data-bbox="598 941 1186 1047">Board walk ends well above the high water mark and has a slope of 20.5% and a drop off into sand</p> <p data-bbox="598 1274 1102 1307">125' of sand surface to the water's edge</p>	<p data-bbox="1218 235 1942 349">Replace the existing boardwalk with a new system with adjustable footings to protect dune surface and allow for leveling to maintain appropriate running and cross slopes</p> <p data-bbox="1218 389 2005 462">Go above the 60" allowed minimum width to at least 6' wide to allow passing on the route as well as side-by-side walking</p> <p data-bbox="1218 503 2005 609">Reduce running slope to 5% where possible & no steeper than the allowable 10% max. for very short segments (less than the 30' max. allowable)</p> <p data-bbox="1218 649 2005 722">provide level landings 6'X6' at the top and bottom of any steep slope segment greater than 5% slope</p> <p data-bbox="1218 763 1974 836">trim/remove encroaching vegetation back far enough that it doesn't grow into the beach route during the season</p> <p data-bbox="1218 941 2005 1047">Recommend extending the new beach route surface to the high water mark and create a large water's edge platform for a "hanging out space that is off to both sides of the route end.</p> <p data-bbox="1218 1088 2005 1161">Recommend adding a gangway off the route end as close to the water's edge as practical.</p> <p data-bbox="1218 1201 2005 1307">Recommend adding a beach to water transfer system from the beach platform to the water's edge to facilitate access into the water.</p>

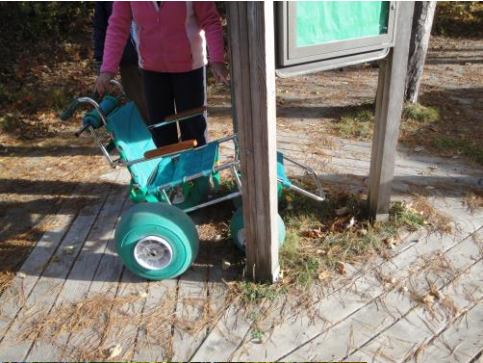
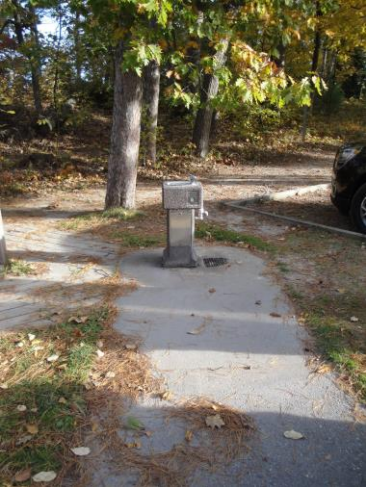
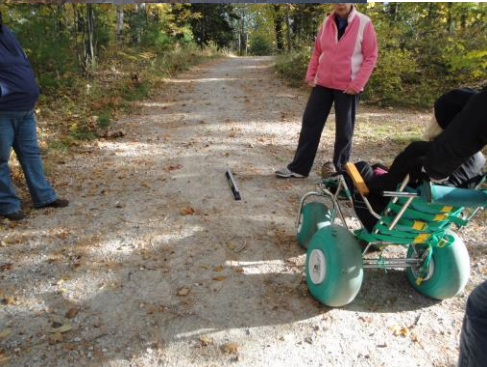
Photo/Location Description	Barrier Description	Accessibility Feature Design Recommendations
<p data-bbox="92 177 504 240">Accessible Routes & Clear Space to Amenities</p>

<p data-bbox="606 326 1192 389">Route to kiosk too narrow at 24" where it connects to the route from the water fountain</p> <p data-bbox="606 472 1192 535">No accessible surface & a drop off in the clear space</p> <p data-bbox="606 732 1203 795">Clear space at spigot side of water fountain too narrow at 16" between drain & route edge</p> <p data-bbox="606 1211 1192 1274">Route from parking to board walk to the beach is too steep with slopes up to 10.3%</p>	<p data-bbox="1241 253 1990 427">Replace the route surface from the water fountain to the kiosk and around and under the kiosk creating a smooth seamless route and clear space so wheels don't fall off the route. This will also make maintenance of the area easier as well.</p> <p data-bbox="1241 472 1997 613">Kiosk height meets current ADA minimum requirements, but to make the information more universally accessible, suggest lowering kiosk so information is centered at 48" which is more viewable from a seated position as well as for children.</p> <p data-bbox="1241 732 2003 837">Add accessible surface in the clear space of the water spigot at least 36" from the ground drain for a side approach for use of the spigot</p> <p data-bbox="1241 1211 1997 1274">Re-route the path to the board walk to reduce slopes to less than 5%</p>

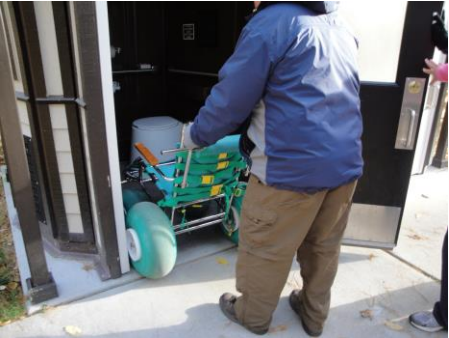
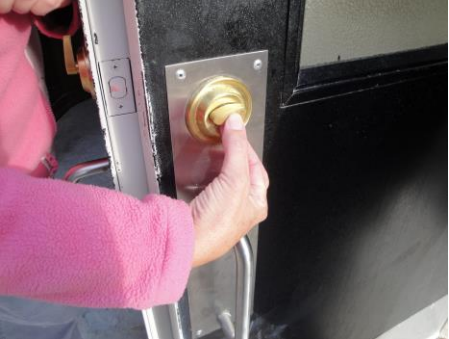
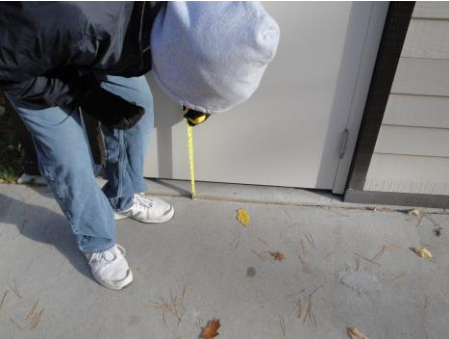
Photo/Location Description	Barrier Description	Accessibility Feature Design Recommendations
<p>Toilets</p>

<p>33" doors are too narrow for the beach wheelchair to fit in</p> <p>Pinch-grasp/wrist-twist lock on men's door</p> <p>Concrete entry pad is sinking creating a change of level & 3% slopes</p>	<p>Clear space may not meet the required space configuration for toilet rooms - check the design plans from the manufacture to confirm compliance with ADA space requirements. If it is determined that the design is indeed accessible mark as such with appropriate signage with braille and mount signs on the latch side of the door.</p> <p>If it is determined that the existing toilet design doesn't meet accessibility requirements add a new universally accessible single user family toilet room with extra-large clear space & a baby changer. The larger space will accommodate someone using a wheelchair or an opposite gender care giver assisting someone, as well as families with a little one in a stroller.</p> <p>Replace lock with same design as women's door that does not require pinch-grasp/wrist-twist operation.</p> <p>Level the concrete entry pad to eliminate the step up into the toilet</p>

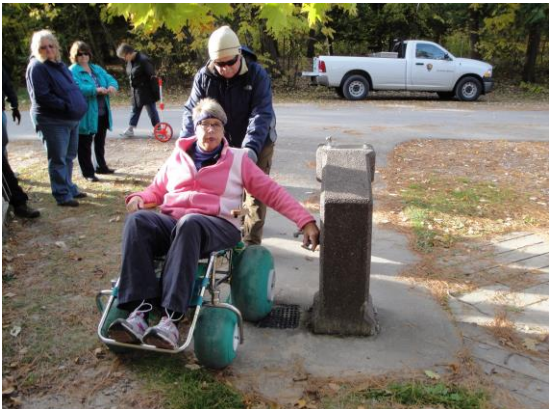
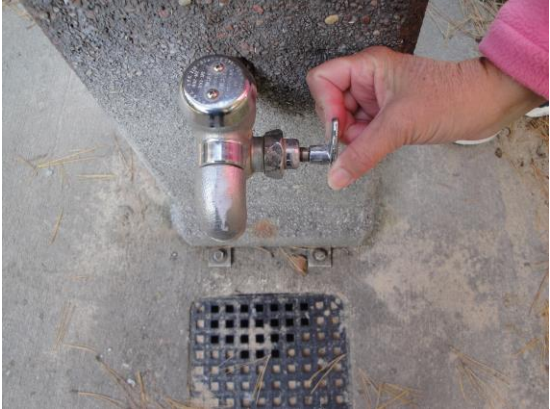
Photo/Location Description	Barrier Description	Accessibility Feature Design Recommendations
<p>Potable water source</p>

<p>Clear space too narrow at 16" from drain grate</p> <p>Spigot requires pinch grasp/wrist twist to operate</p>	<p>Expand the clear space for side or front approach</p> <p>Replace the operating mechanism to be one-hand operable without pinch grasp/wrist twist such as a large paddle style lever that can be operated with a fist or flat hand</p>

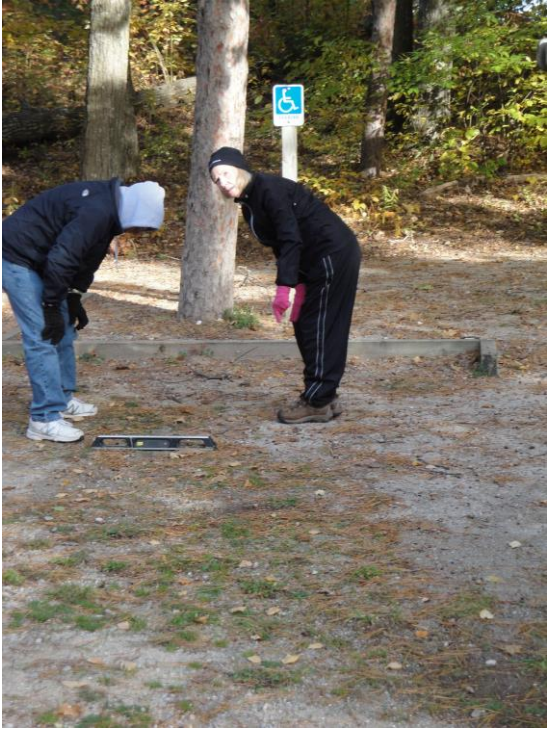
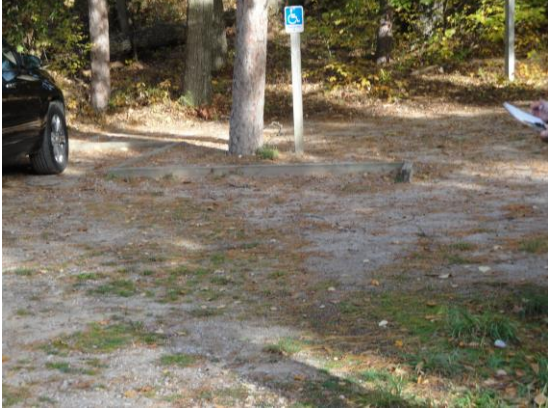
Photo/Location Description	Barrier Description	Accessibility Feature Design Recommendations
<p data-bbox="94 180 325 207">Accessible parking</p>

<p data-bbox="667 253 1207 321">One parking space with chips/fines surface slopes & cross slopes up to 3%</p> <p data-bbox="667 402 1117 467">Random vegetation creates unstable surface conditions</p> <p data-bbox="667 1065 982 1092">No access aisle indicated</p>	<p data-bbox="1241 253 1934 321">Level the parking and access isle space surface, remove vegetation and replenish accessible chips/fines surface.</p> <p data-bbox="1241 1065 1997 1133">Designate an access isle space as well. Suggestion is to strip the space with blue spray paint on the gravel surface.</p>

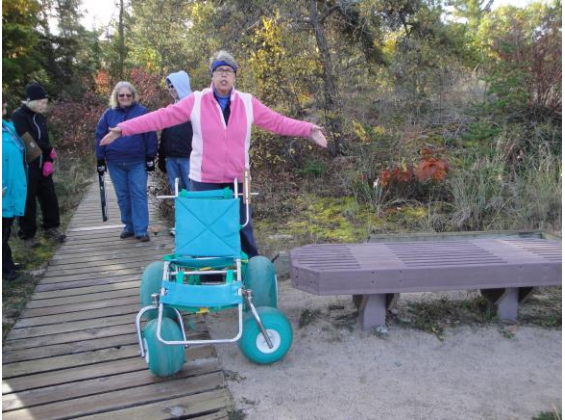
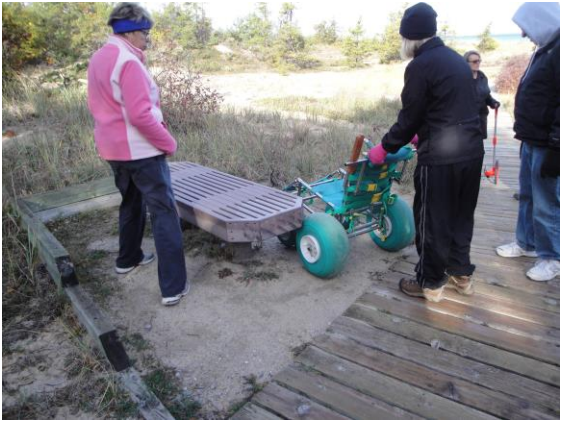
Photo/Location Description	Barrier Description	Accessibility Feature Design Recommendations
<p data-bbox="94 180 170 204">Bench</p>

<p data-bbox="667 289 1199 354">Clear space is too narrow and overlaps the beach access route</p> <p data-bbox="667 732 1199 833">Surface change of level/drop off between the surface surrounding the bench & the beach access route surface</p>	<p data-bbox="1241 289 1969 354">When the beach access route is replaced locate it away from the bench end creating a non-overlapping clear space</p> <p data-bbox="1241 732 1969 797">Level the surface surrounding the bench and eliminate the change of level from the beach access route.</p>

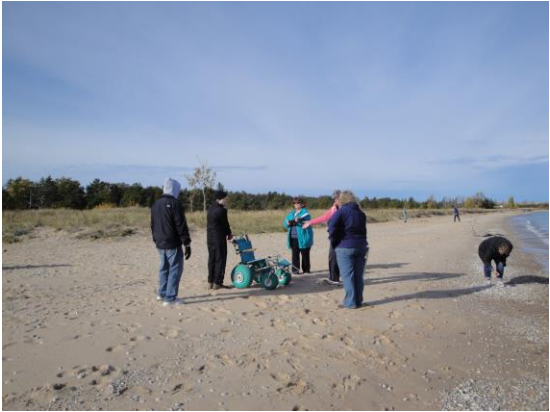
Photo/Location Description	Barrier Description	Accessibility Feature Design Recommendations
<p data-bbox="94 175 319 203">Beach Wheelchair</p>

<p data-bbox="667 289 1209 391">Old design of beach chair is very heavy and difficult to push on the sand (even with no one in it!!)</p>	<p data-bbox="1241 253 1992 391">Recommend replacing the old beach chair with a newer more user friendly model and keeping this old chair available for use as a trail hiking chair on trails with relatively level packed earth surfaces with trail treads at least 4'wide.</p>
