Sleeping Bear Dunes Beach/Water Access Site Accessibility Evaluation & Design Recommendations

Beach/Water Access Site: Good Harbor Beach

Date Assessed: 9/27/15

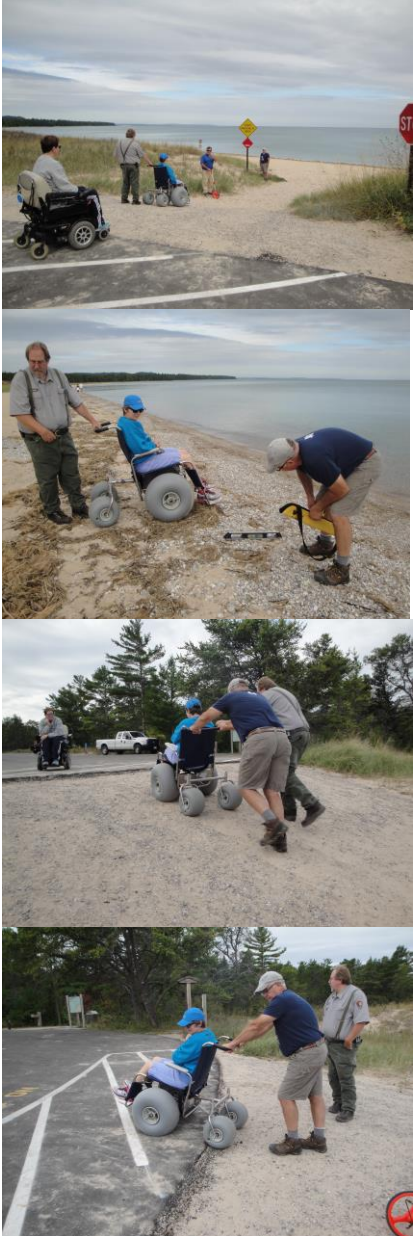
Photo/Location Description	Barrier Description	Accessibility Feature Design Recommendations
<p data-bbox="94 170 577 203">Beach Access Routes to Waters' Edge</p>

<p data-bbox="735 203 1228 276">No accessible Beach Access Route to the water's edge.</p> <p data-bbox="735 316 1228 535">The route to the beach and water's edge is 125' of sloping inaccessible sand. There is a sign indicating county road property to the water. Slopes: 19%, 14.9%, 19.8%, 41.2%, 10.2%, 4.7%, 6.3%, 7.9%</p> <p data-bbox="735 576 1228 649">3" change of level from the asphalt to the inaccessible sand surface</p> <p data-bbox="735 690 1228 795">45' from asphalt to sign. First 25' has some large gravel mixed in with the sand, next 20' soft sand.</p> <p data-bbox="735 836 1228 909">80' from the sign to the water's edge, soft sand to high water mark</p>	<p data-bbox="1260 170 2005 462">It may not be possible to make any route improvements on the road end property but the park may be able to add and accessible over-the-sand walk way to the high water mark. Consider a flow-thru docking material or the EZ Trail product. These are both temporary/portable surfaces that are put in for the season & removed for the winter. Both provide dune protection while directing human behavior and making the beach more universally accessible.</p> <p data-bbox="1260 503 2005 576">Go above the 60" allowed minimum width to at least 6' wide to allow passing on the route as well as side-by-side walking</p> <p data-bbox="1260 617 2005 722">Keep running slope to less than 5% where possible & no steeper than the allowable 10% max. for very short segments (less than the 30' max. allowable)</p> <p data-bbox="1260 763 2005 836">provide level landings 6'X6' at the top and bottom of any steep slope segment greater than 5% slope</p> <p data-bbox="1260 876 2005 1015">Recommend extending the new beach route surface to the high water mark and create a large water's edge platform for a "hanging out space that is off to both sides of the route end.</p> <p data-bbox="1260 1055 2005 1128">Recommend adding a gangway off the route end as close to the water's edge as practical.</p> <p data-bbox="1260 1169 2005 1274">Recommend adding a beach to water transfer system from the beach platform to the water's edge to facilitate access into the water.</p>

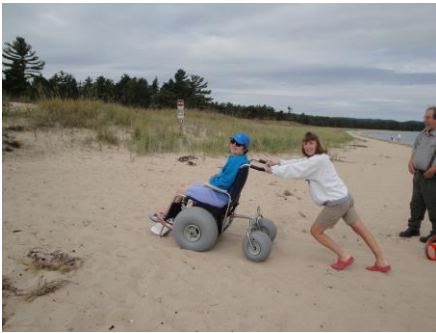
Photo/Location Description	Barrier Description	Accessibility Feature Design Recommendations
<p data-bbox="94 142 319 167">Beach Wheelchair</p>

<p data-bbox="739 180 1228 280">Old design of beach chair is very heavy and difficult to push on the sand (even with no one in it!!)</p>	<p data-bbox="1266 142 2003 500">Recommend replacing the old beach chair with a newer more user friendly model and keeping this old chair available for use as a trail hiking chair on trails with relatively level packed earth surfaces with trail treads at least 4'wide. Post a sign at the accessible parking space with a photo of the new beach chair and instructions on how to request the use of the chair. Consider having the chair on-site with a lock & call # so people can call for the code to unlock & use.</p>
Photo/Location Description	Barrier Description	Accessibility Feature Design Recommendations
<p data-bbox="94 553 319 578">Information Kiosk</p>

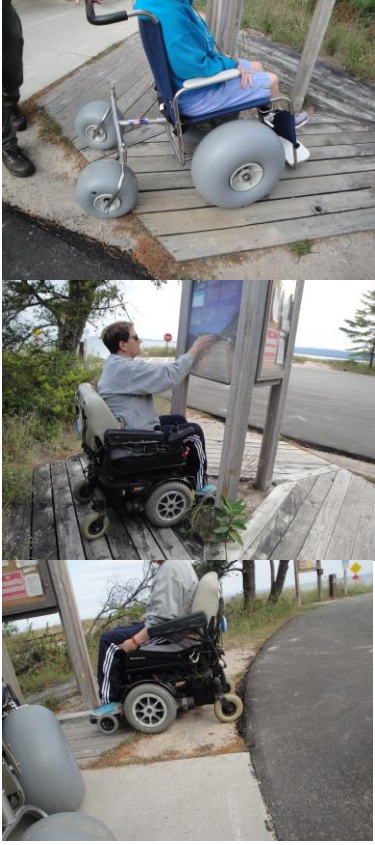
<p data-bbox="739 626 1228 688">Route to kiosk too narrow at 24" where it connects to the route</p> <p data-bbox="739 995 1228 1096">No accessible surface & a change of level drop off in the clear space under the kiosk</p> <p data-bbox="739 1365 1167 1390">Clear space too narrow on all sides</p>	<p data-bbox="1266 587 2003 727">Replace the surface to the kiosk and around and under the kiosk creating a smooth seamless route and clear space so wheels don't fall off the route. This will also make maintenance of the area easier as well.</p> <p data-bbox="1266 773 2003 948">Kiosk height meets current ADA minimum requirements, but to make the information more universally accessible, suggest lowering kiosk so information is centered at 48" which is more viewable from a seated position as well as for children.</p>

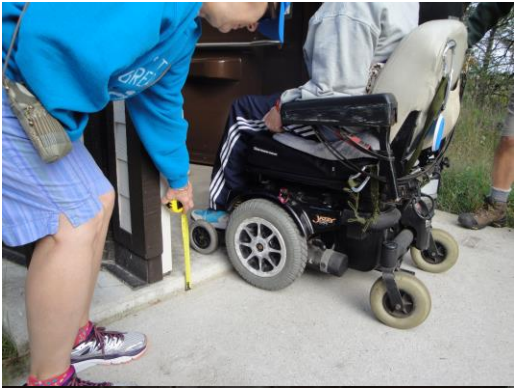
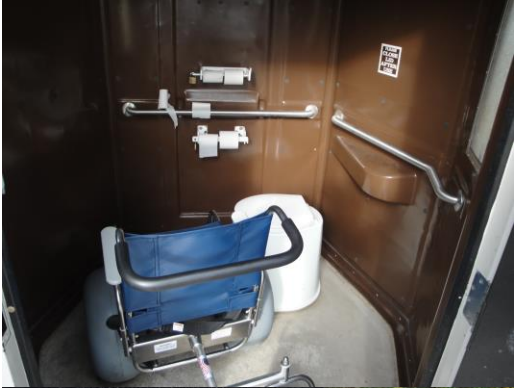
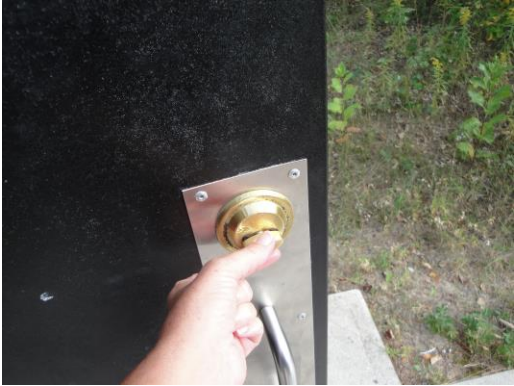
Photo/Location Description	Barrier Description	Accessibility Feature Design Recommendations
<p>Toilets</p>

<p>2" change of level due to sinking concrete entry pad</p> <p>Interior space too small to accommodate someone using the beach wheelchair</p> <p>Lock requires pinch-grasp/wrist-twist to operate.</p>	<p>Level the concrete entry pad to eliminate the step up into the toilet</p> <p>Clear space may not meet the required space configuration for toilet rooms - check the design plans from the manufacture to confirm compliance with ADA space requirements. If it is determined that the design is indeed accessible mark as such with appropriate signage with Braille and mount signs on the latch side of the door.</p> <p>If it is determined that the existing toilet design doesn't meet accessibility requirements add a new universally accessible single user family toilet room with extra-large clear space & a baby changer. The larger space will accommodate someone using a wheelchair or an opposite gender care giver assisting someone, as well as families with a little one in a stroller.</p> <p>Replace lock with same design as women's door that does not require pinch-grasp/wrist-twist operation.</p>

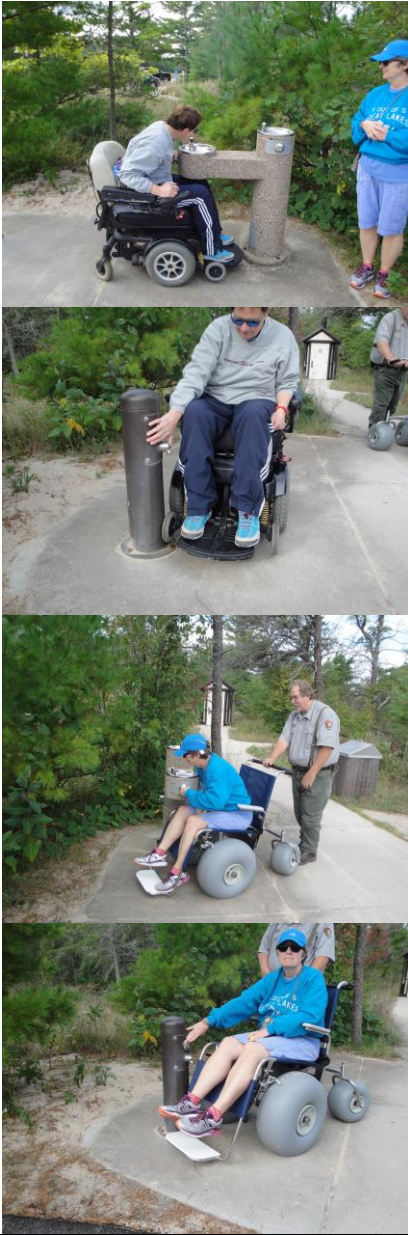
Photo/Location Description	Barrier Description	Accessibility Feature Design Recommendations
<p>Potable water source</p>

<p>Water was turned off so couldn't test the arch of the water height.</p>	<p>Check water flow in the spring to make sure it is high enough (4" min.) to place a cup under.</p>

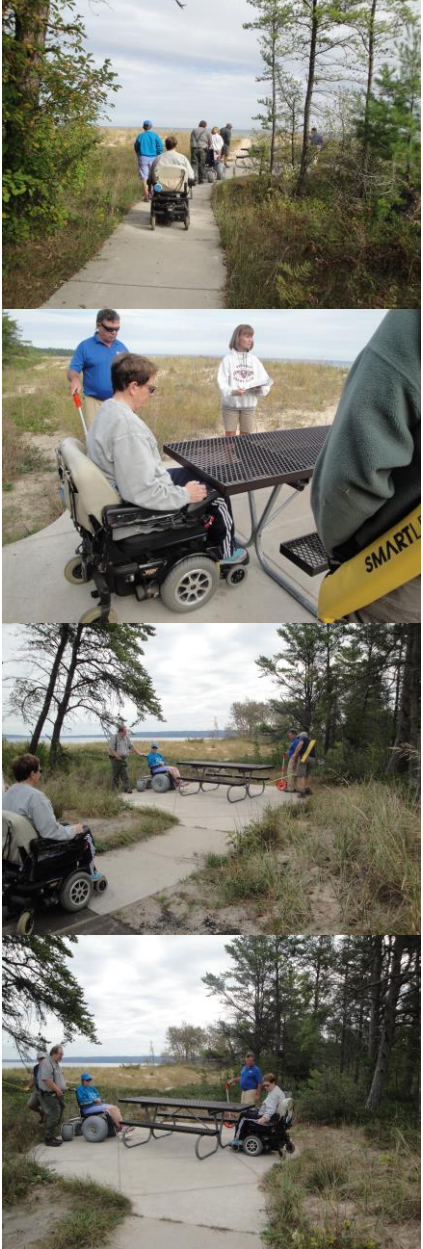
Photo/Location Description	Barrier Description	Accessibility Feature Design Recommendations
<p data-bbox="94 178 252 203">Picnic tables</p>

<p data-bbox="735 211 1218 324">Clear space around the tables at both sites is narrowed due to encroaching vegetation & drifted sand</p>	<p data-bbox="1260 211 1995 324">The clear space meets the minimum requirements for ADA compliance if the encroaching vegetation is kept cleared from the perimeter and the route to the table.</p> <p data-bbox="1260 357 1995 470">Recommendation for future design is to enlarge the clear space by 1' to be more universally accessible and user-friendly.</p>

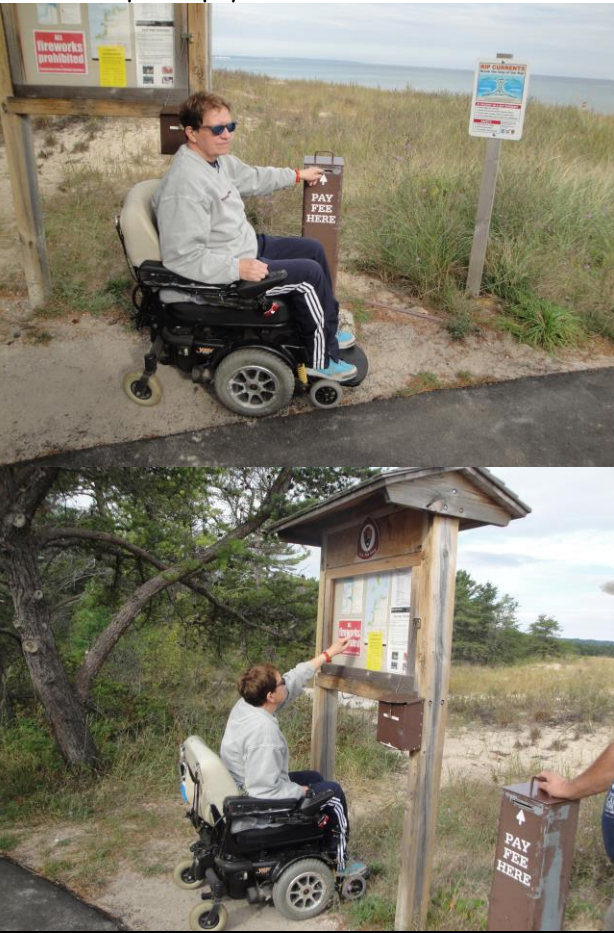
Photo/Location Description	Barrier Description	Accessibility Feature Design Recommendations
<p data-bbox="100 142 441 170">Fee envelopes & pay station</p>

<p data-bbox="739 181 1218 284">Route to fee envelope dispenser & fee payment post has inaccessible sand surface.</p> <p data-bbox="739 771 1201 836">The design of the dispenser requires pinch grasp to operate</p>	<p data-bbox="1268 181 1890 246">Add accessible surface in the clear space of the information kiosk, fee envelop box & pay fee post.</p> <p data-bbox="1268 292 1990 357">Change the design of the envelop dispenser to a style that doesn't require tight pinch grasp to operate.</p>

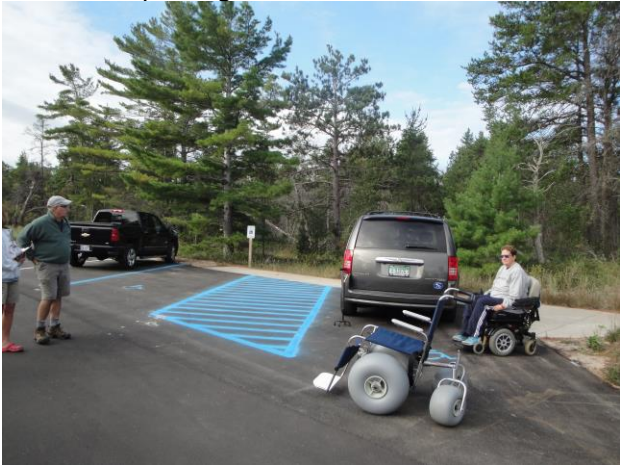
Photo/Location Description	Barrier Description	Accessibility Feature Design Recommendations
<p data-bbox="94 175 325 207">Accessible parking</p>

<p data-bbox="739 215 802 240">none</p>	<p data-bbox="1266 215 1329 240">none</p>
